Solar Resource Mapping in Pakistan

SITE INSTALLATION REPORT

July 2015

**ESMAP Tier2 Meteorological Station
Installation Report:
Balochistan University of Engineering and
Technology, Khuzdar**

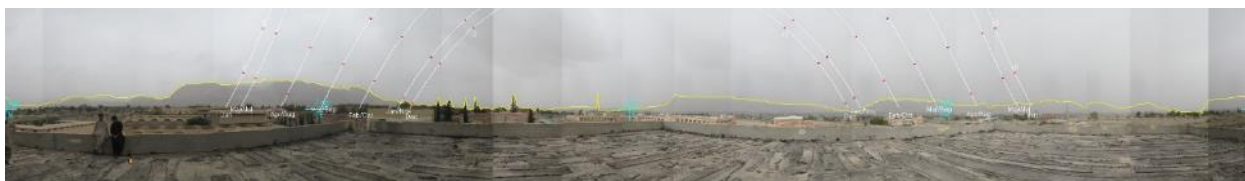
360° view from the sun sensor position with sun paths throughout the year

Only minor and uncritical influences by obstacles near horizon at sunrise and sunset, details of the analysis contained in site evaluation report.
